3 EXTENT OF WORKS

The town of Tarcutta is located between Gundagai and Holbrook, on the Hume Highway. This contract is for the demolition and removal of building and structures on the Roads and Traffic Authority (RTA) property at the town of Tarcutta. RTA has full ownership of the building and structures.

Hazardous Material Survey & Management Plan

6 College Street
Tarcutta, NSW
February 2009

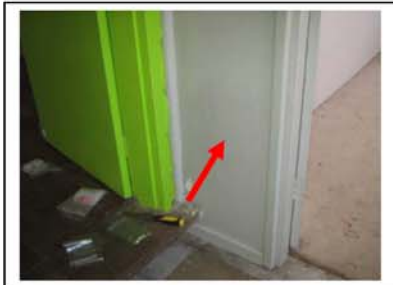
- Photo 1 – Wall sheeting in Bedroom 3
- Photo 2 – Wall sheeting adjacent Bedroom 3
- Photo 3 – Ceiling sheet between Laundry and Bedroom 3
- Photo 4 – Wall sheeting in Laundry
- Photo 5 – Electrical Meter Box backing sheet

Photograph 1: Bedroom 3 - wall sheet
(Sample No. 4447 – A1)

- Removal of asbestos materials in accordance with WorkCover Codes of Practice, relevant OH&S standards and dispose of in an appropriate waste management centre.

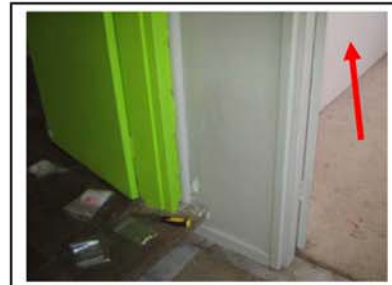
Photograph 2: Wall sheet - adjacent
bedroom 3 (Sample No. 4447 – A2)

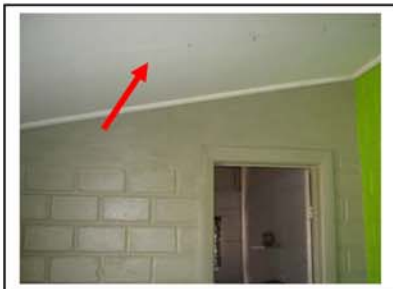
Photograph 3: Ceiling sheet between
laundry and bedroom 3 (Sample No.
4447 – V₁)

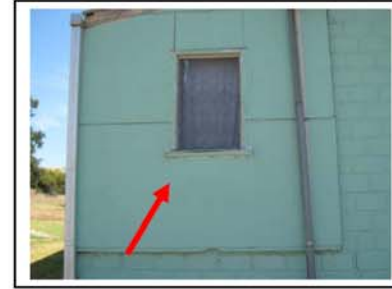
Photograph 4: Wall sheet
(outside/inside same wall) – laundry
(Sample No. 4447 – V₂)

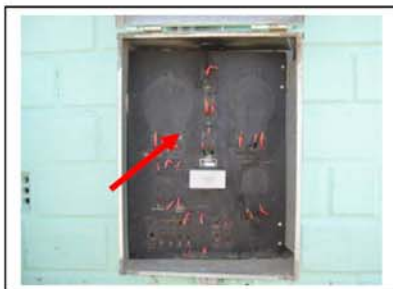
Photograph 5: Meter box backing
sheet (Sample No. 4447 – V₃)

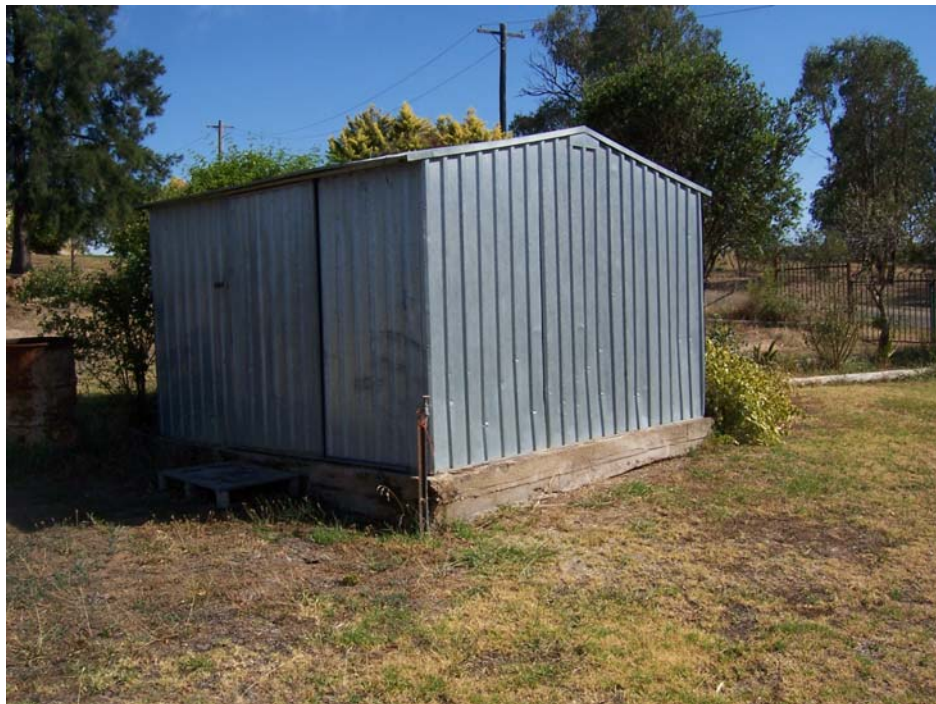
Figure 2 : Metal garden shed and foundation to be retained

- Metal garden shed and foundation slab (Figure 2).
- All trees located on the property
- All boundary fencing and gates

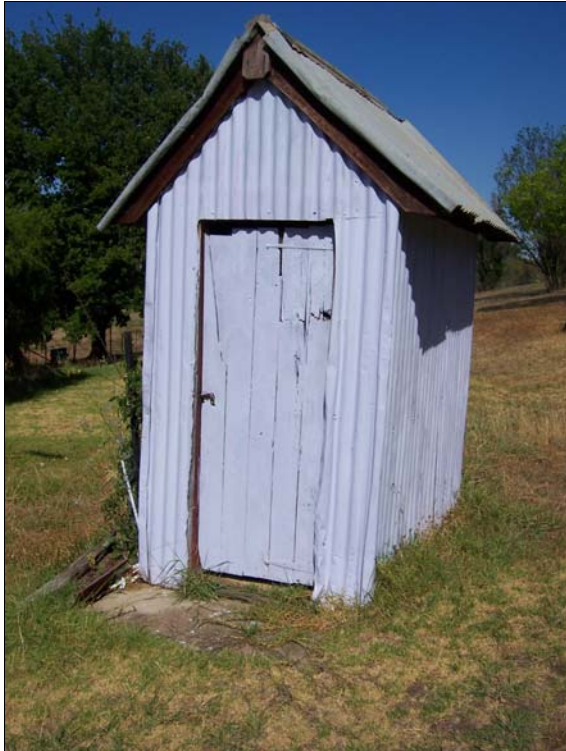
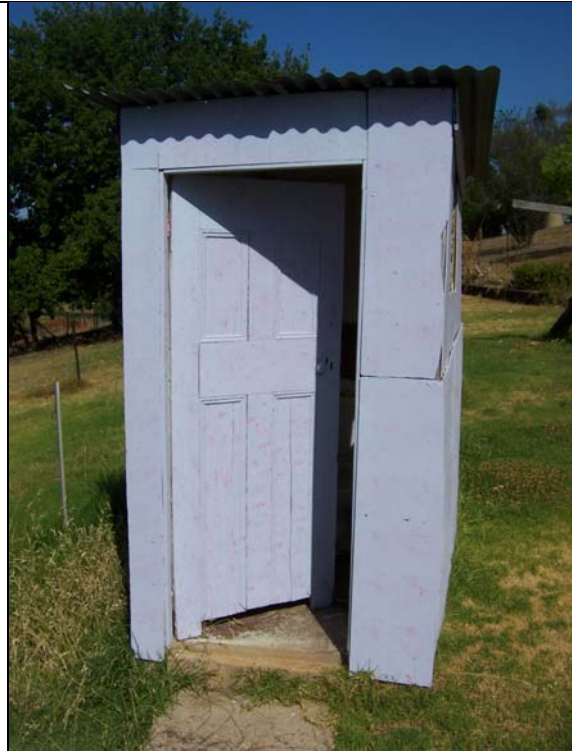
Figure 3 – Water Closet

Figure 4 – Water Closet

- Two external water closet structures (Figure 3 and 4).
- Timber framed carport structure with chicken coop (Figure 5).
- Corrugated iron woodshed (Figure 6).

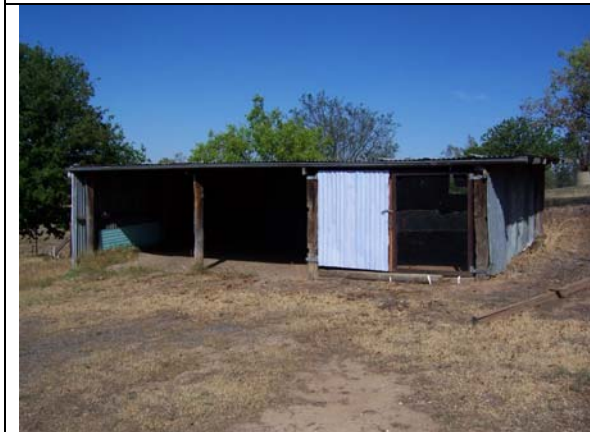
Figure 5 – Carport and chicken coop

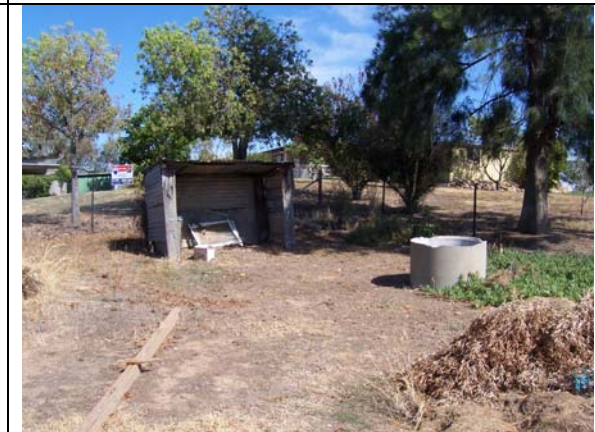
Figure 6 – Corrugated iron wood shed

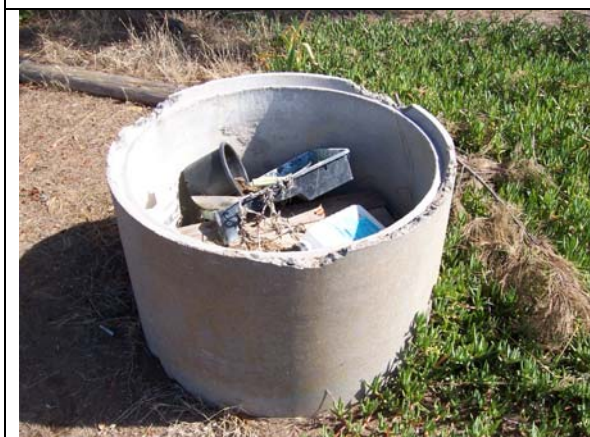
Figure 7 – Concrete shell and waste

- Redundant circular concrete shell and waste (Figure 7).
- Concrete block BBQ and bird bath (Figure 9 and 10).
- Wire plant arch (Figure 11)
- Timber post and wire washing line and garden bed parallel to washing line including all plants and wooden edging. Level ground to match surrounding surface level (Figure 12 and Figure 13).

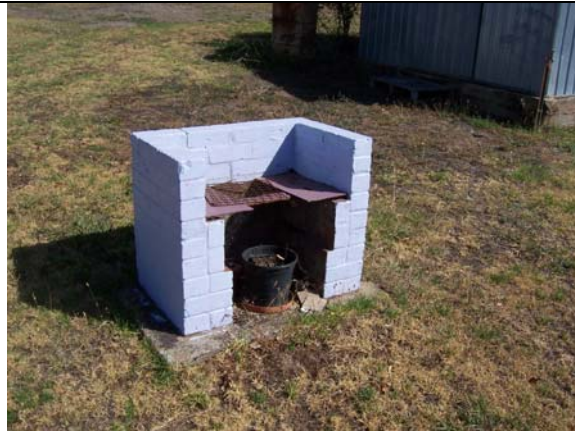
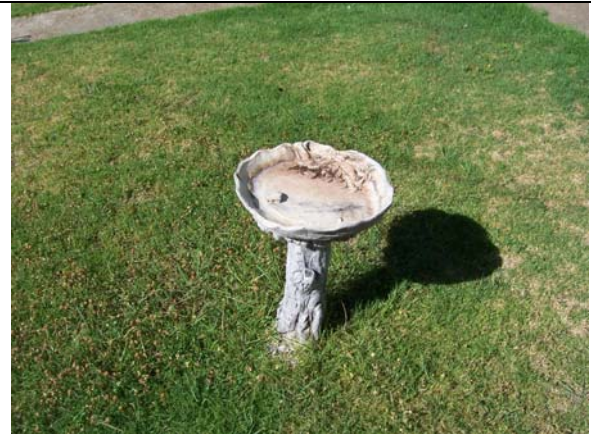
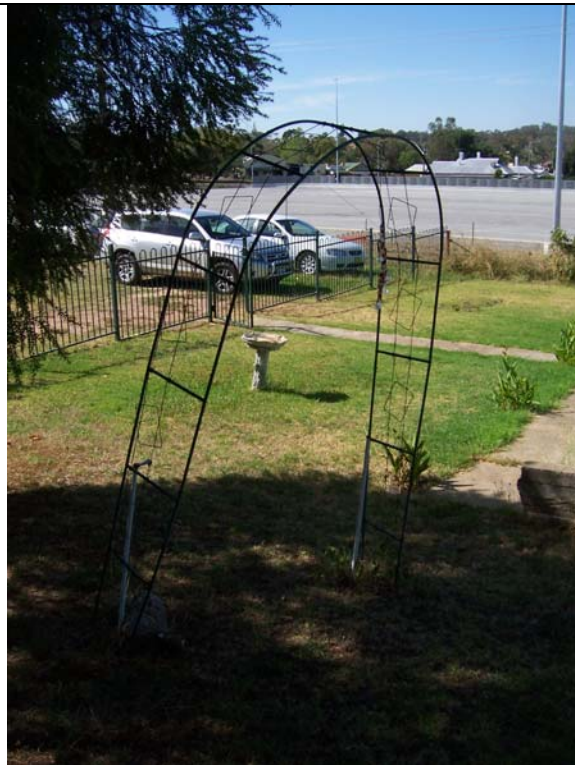
Figure 9 – Concrete BBQ

Figure 10 – Bird bath

Figure 11 – Metal Arch

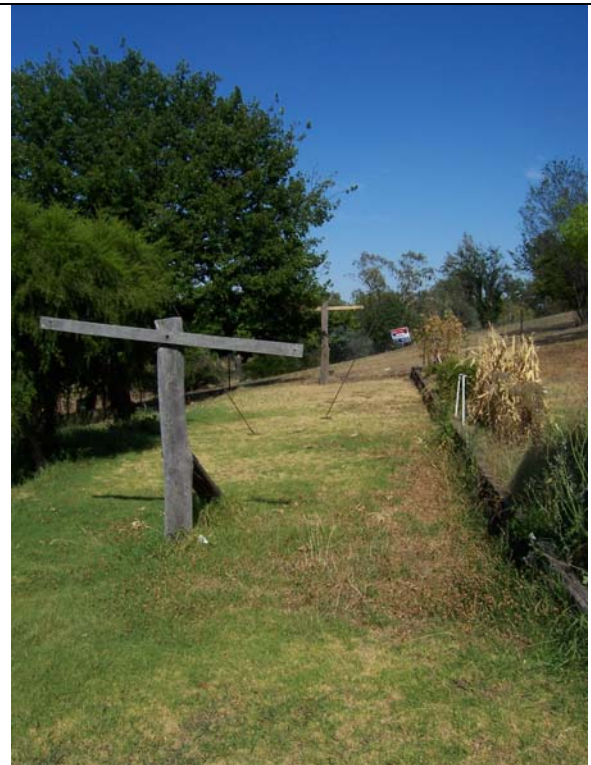
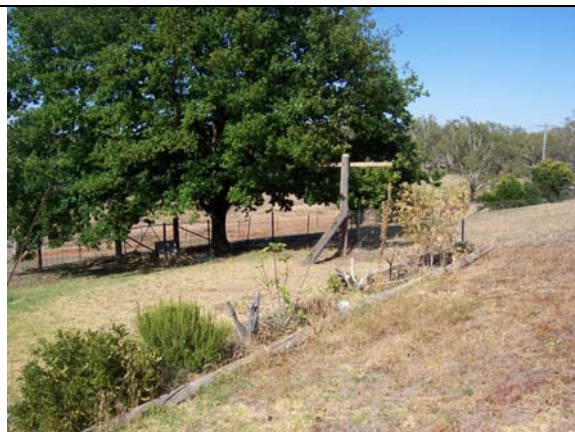
Figure 12 – Timber washing line and garden bed

Figure 13 – Garden bed and shrubs parallel to washing line to be demolished
